102 Metal Repair Fluid

102 Metal Repair Fluid is a two component solvent free epoxy metal fairing compound. The product has been designed for use on a wide range of metallic surfaces and once cured is readily machinable.

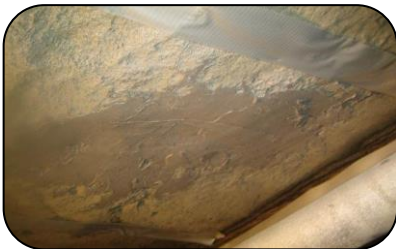
Base of tank, plate bonded and then resurfaced using 102 Metal Repair Fluid.

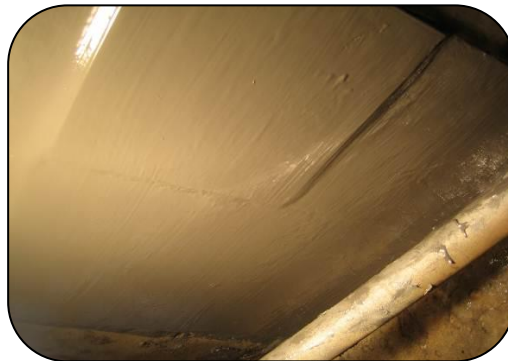
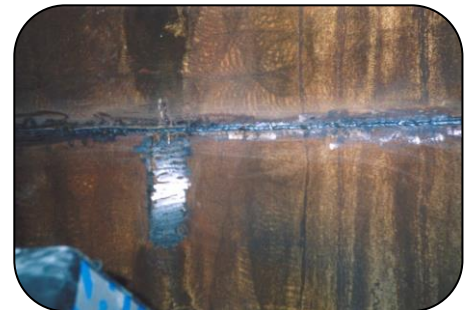
Damaged tank seams filled and rebuilt using 102 Metal Repair Fluid

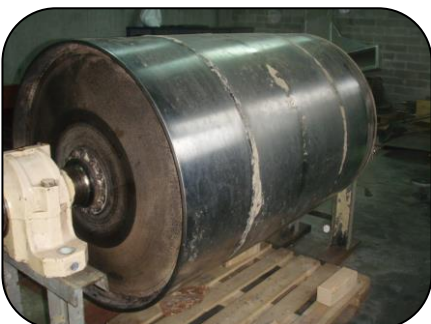
Belt rollers resurfaced using 102 Metal Repair Fluid and Aluminium Oxide

The product is suitable for filling mechanically or abrasive blast cleaned surfaces where excessive pitting and scarring has been caused by corrosion or chemical attack. The material can also be used with aluminium oxide aggregates to create anti-slip finishes on metallic surfaces such as belt rollers, brake test rollers and steps.
